Historic Lighthouse Preservation Handbook

1997

PD-375

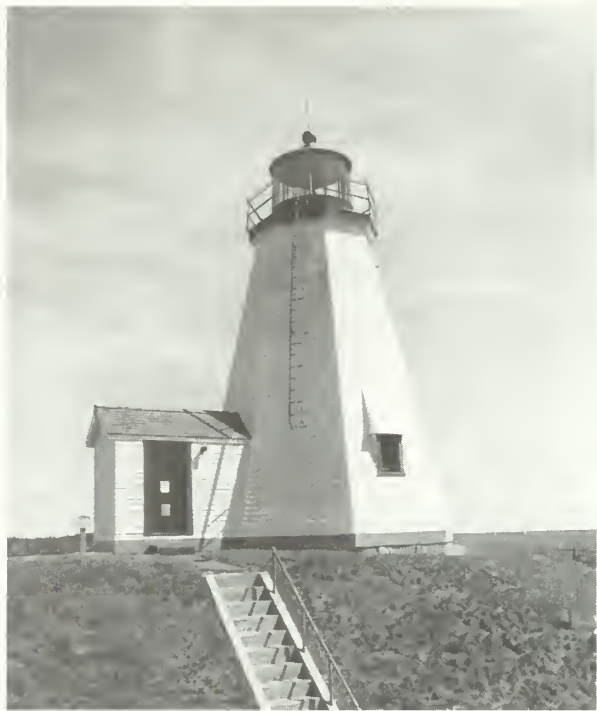
Figure 3. Gurnet Point Lighthouse, wooden tower near Plymouth, Massachusetts.

Wooden tower: Most early wooden towers have burned and/or been replaced. Prospect Harbor Lighthouse (1891), Maine, is a good example of a stand-alone, conical wooden light tower. Plymouth/Gurnet Point Light (1843),

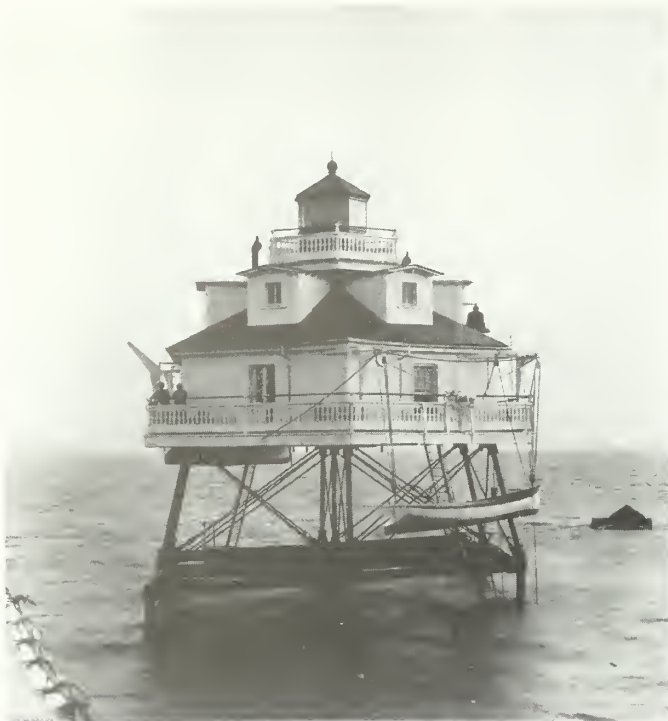
Figure 6. Thomas Point Shoals Lighthouse with screwpile foundation located in Maryland's Chesapeake Bay; shown here in 1885.

Screwpile: To increase the holding power of the pile, a screw-like flange was fastened to the bottom of the pile and wound like a screw into the substrate. There are two principal screwpile type lighthouses, 1) low spider-like foundations for rivers, bays, and sounds, and 2) tall offshore coastal towers. Perhaps as many as 100 spider-like screwpile lighthouses were built throughout the Carolina sounds, the Chesapeake Bay, Delaware Bay, along the Gulf of Mexico, and one even at Maumee Bay (1855) on Lake Erie in Ohio. Thomas Point Shoals Lighthouse (1875), Maryland, is the oldest extant, unmoved, spider-like screwpile lighthouse in the United States. The first of the tall skeletal screwpile coastal towers built in the United States was Carysfort Reef Lighthouse (1852), Florida, which still stands. A few offshore screwpile skeletal tower lighthouses built on coral reefs used foot plates or disks to help disperse the weight of the tower. Examples in the Florida Keys include Carysfort Reef Lighthouse (1852), Fowey Rocks Lighthouse (1878), and American Shoal Lighthouse (1880).

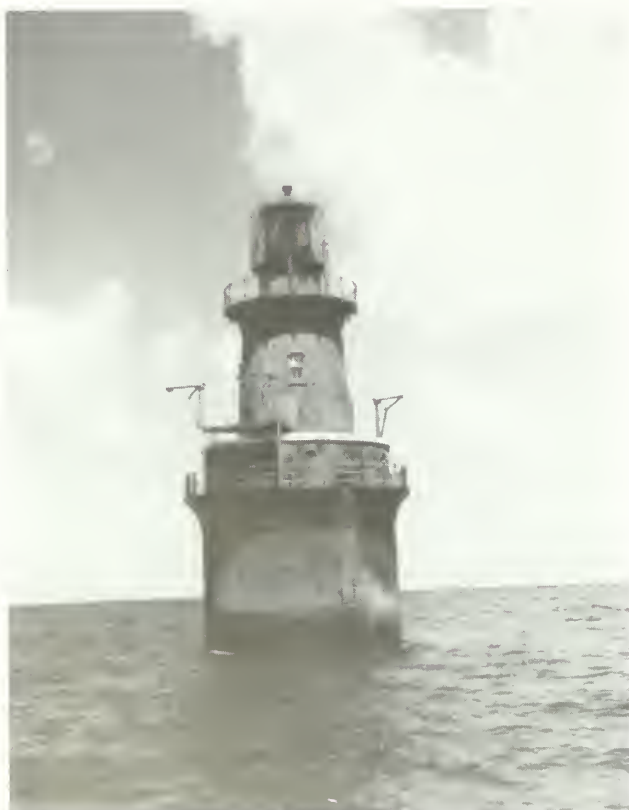
Figure 7. Sabine Bank Lighthouse with caisson foundation in Texas.

Caisson: Caisson foundations were best suited for unconsolidated bottoms composed of sand or mud. The caisson lighthouse type used a large cast-iron cylinder, which was sunk on the bottom and filled with rock and concrete to form a foundation. The caisson foundation was sturdier and better able

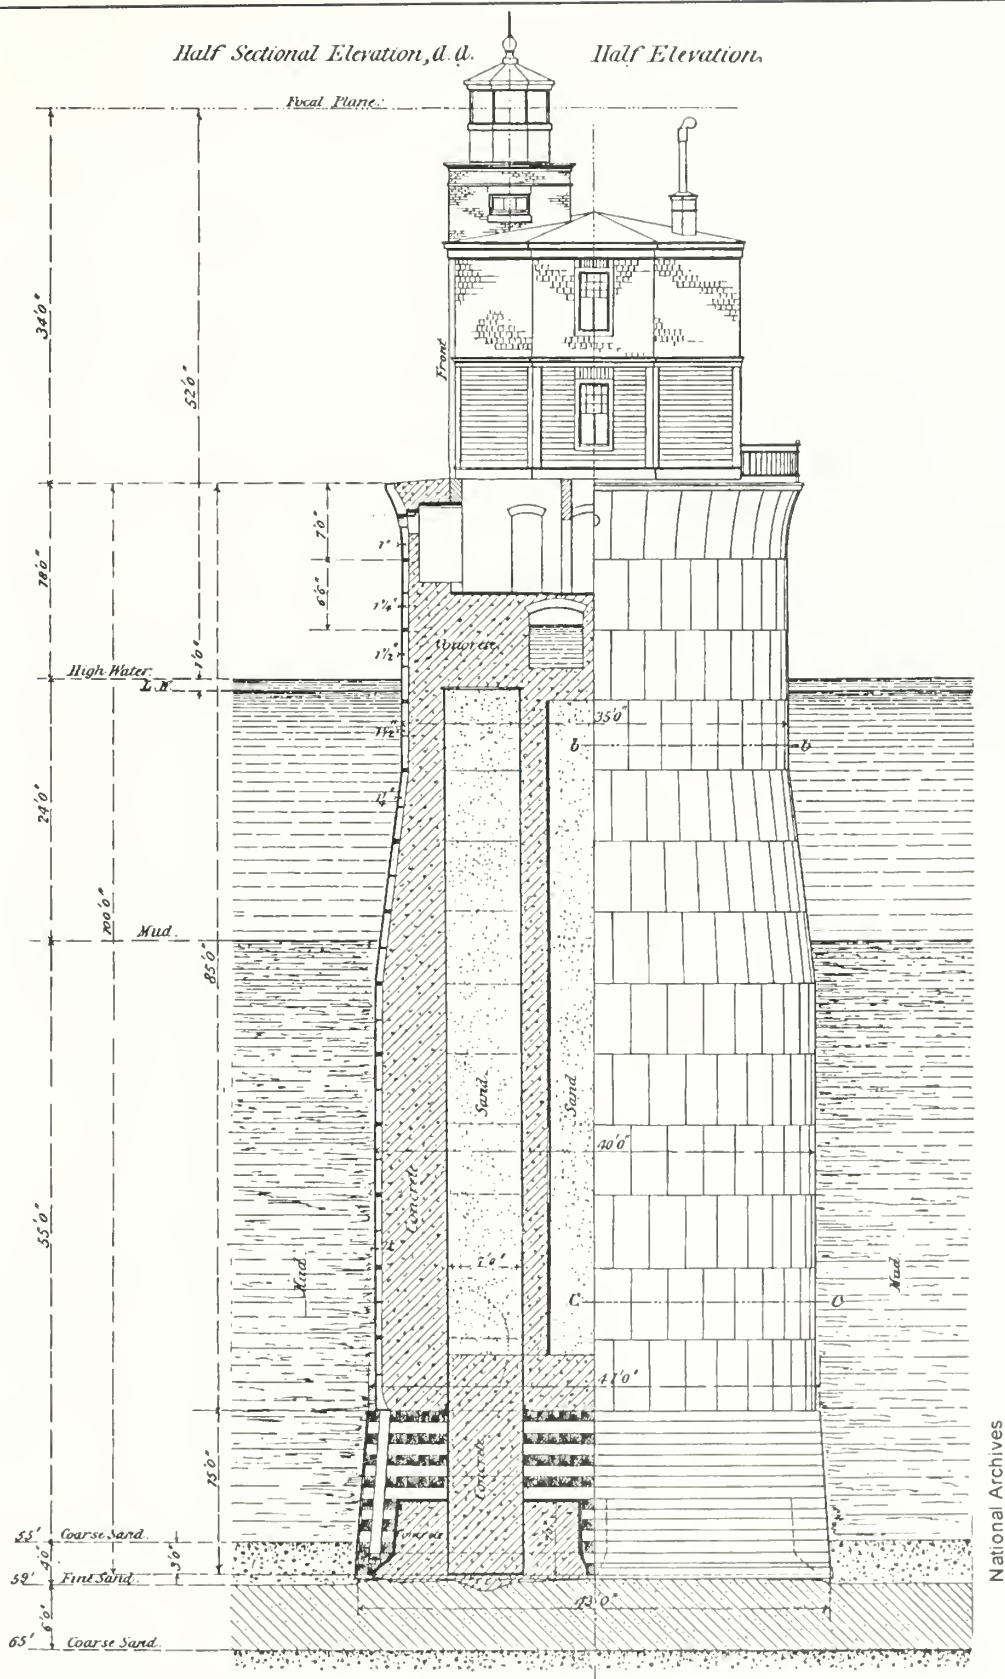
Figure 8. Construction drawing detailing the caisson foundation for Baltimore Lighthouse in Maryland's Chesapeake Bay.

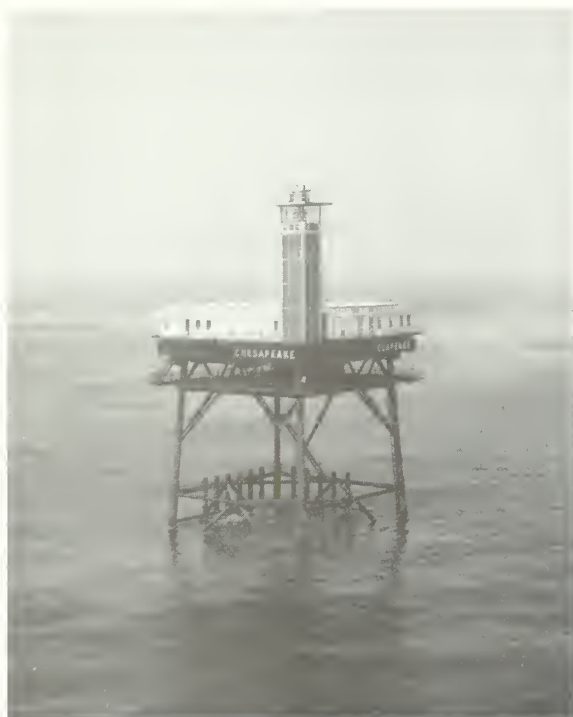
Figure 9. Chesapeake Light Station, Texas tower at entrance to Chesapeake Bay.

Texas Tower Type: A relatively recent technological development in lighthouse construction was the Texas tower type which replaced exposed lightships offshore. These so-called Texas towers were adaptations modeled on the offshore oil drilling platforms first employed off the Texas coast. The first Texas tower lighthouse in the United States was the Buzzards Bay Light, located in Buzzards Bay, Massachusetts, and commissioned on November 1, 1961. It has been extinguished and may be dismantled. A total of six Texas tower lighthouses have been constructed.

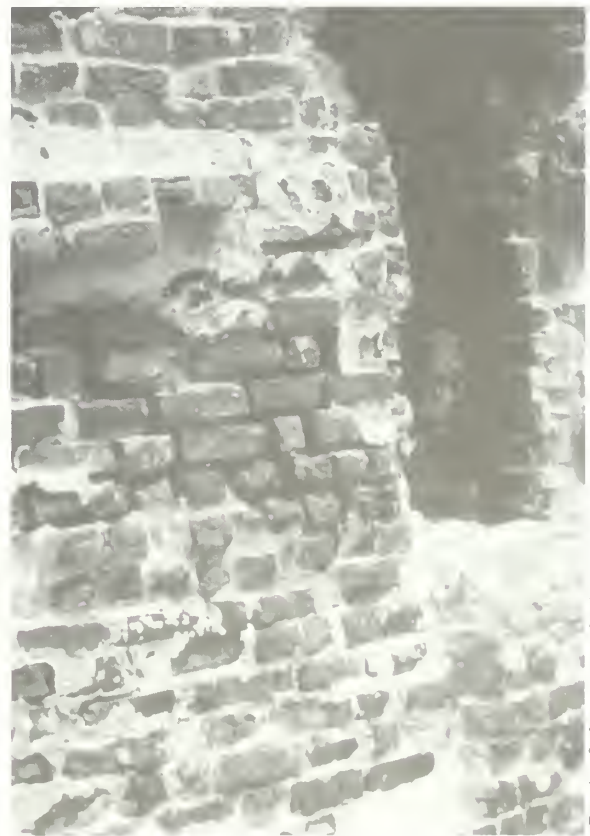
Figure 5. The coating that once protected the soft bricks of this lighthouse was not maintained; the severe deterioration required the replacement of nearly 25,000 bricks.

In some instances the vulnerable, softer masonry surfaces were not covered with a protective coating, or the protective coating was not maintained and the masonry has since deteriorated. In these cases the protective coating needs to be reinstalled after the required repairs are made, or the masonry may need to be consolidated by a qualified architectural conservator.

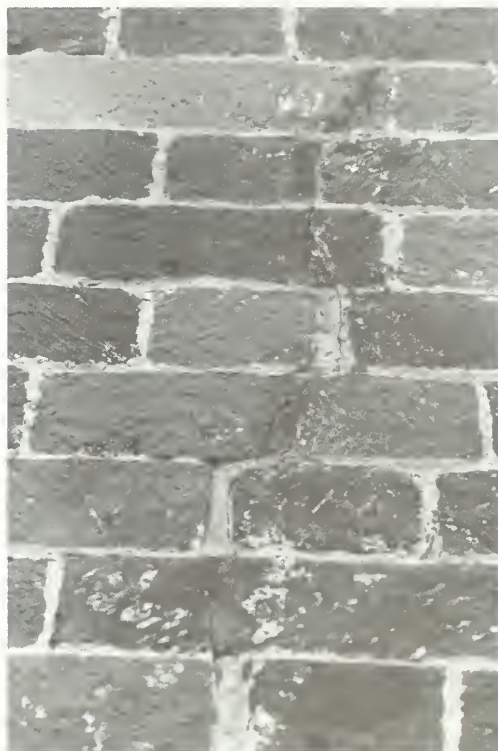
Figure 15. Cracks such these in a sandstone lighthouse should be monitored for movement prior to treatment.

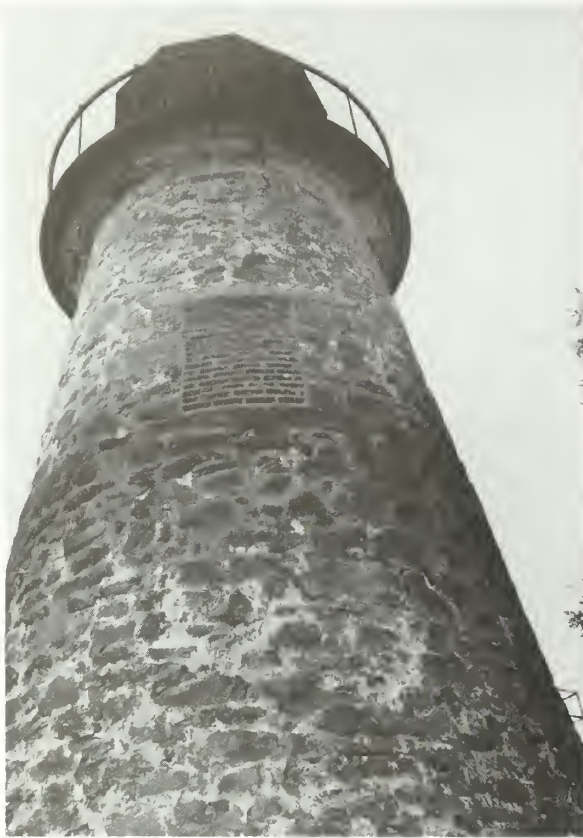
Figure 16. An example of a reversible masonry stabilization treatment for the window opening that has prevented structural deterioration and moisture infiltration.

‘mothballed’ period. If funds are insufficient to make structural repairs, structural stabilization should be performed as a less expensive temporary alternative. Temporary blocking in of window and door openings and installation of interior or exterior shoring or bracing are all stabilization methods. Figure 16 illustrates a window opening that has been stabilized with brick infill. Brick is a historic stabilization method in stone masonry construction. If this method is used, the

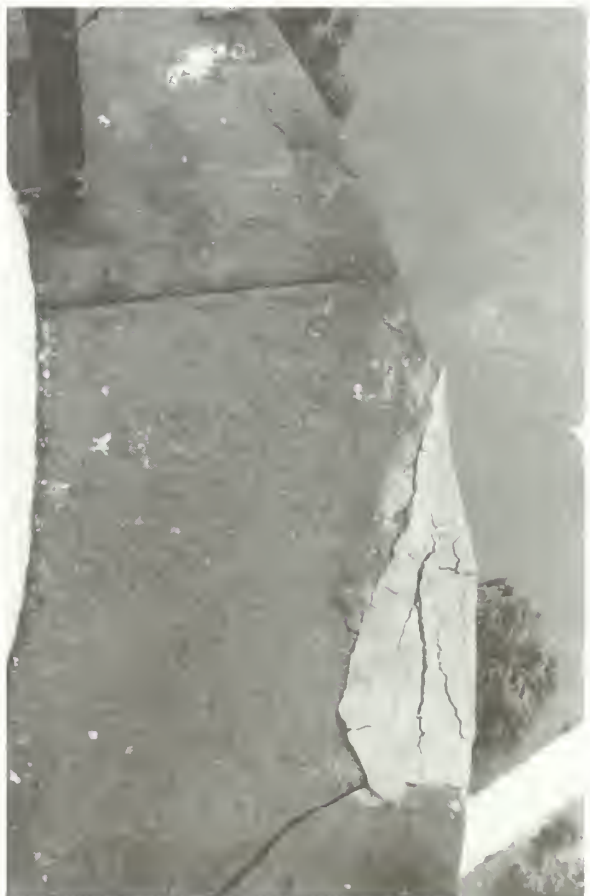
Figure 22. A failing repair made to a stone gallery deck using a simulated stone material. A stone dutchman repair should have been used.

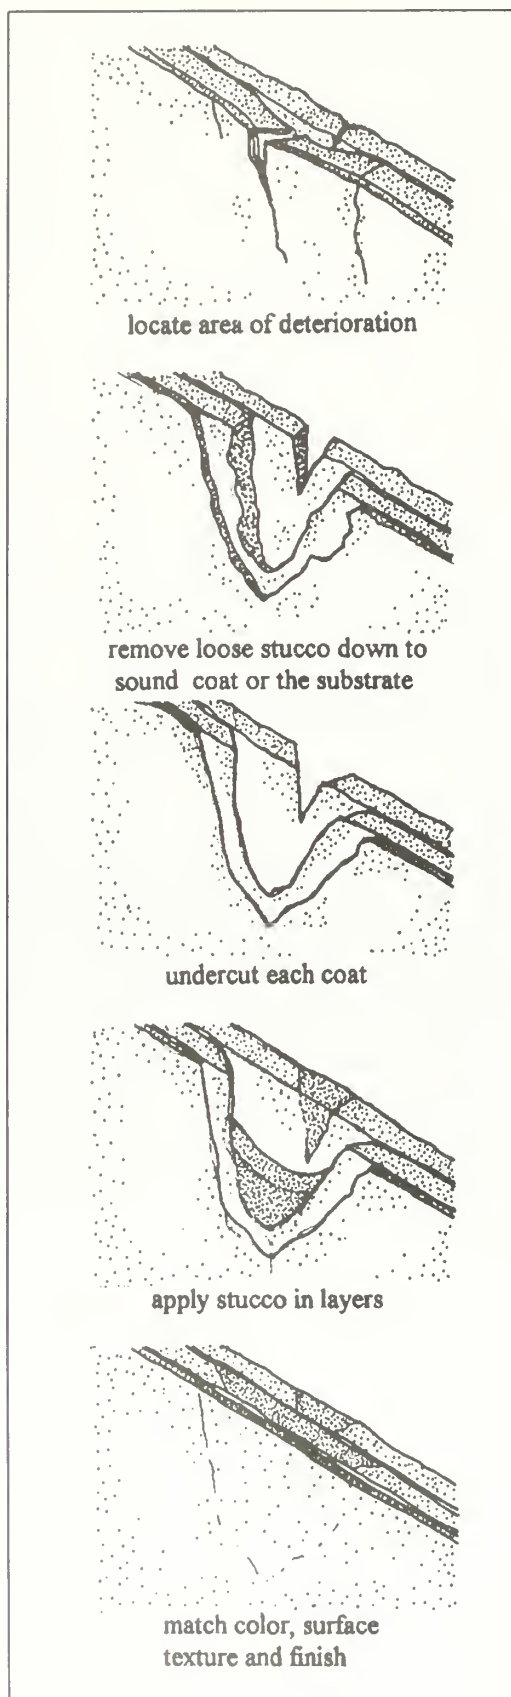
Figure 23. The five basic steps of stucco repair; each layer of stucco must be patched separately. (NPS drawing)

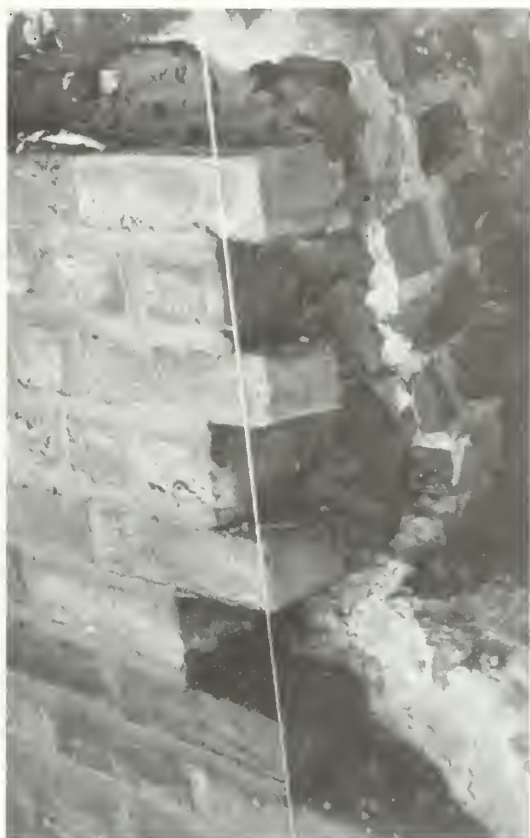
Figure 27. View of repairs being made to the exterior wall. A new brick wythe is being installed where bricks were missing, using mortar that matches the strength of the new and historic bricks. Masonry anchors are used to attach the new wythe to existing wall. The deteriorated mortar joints in the extant wall were repointed with a matching mortar mix.

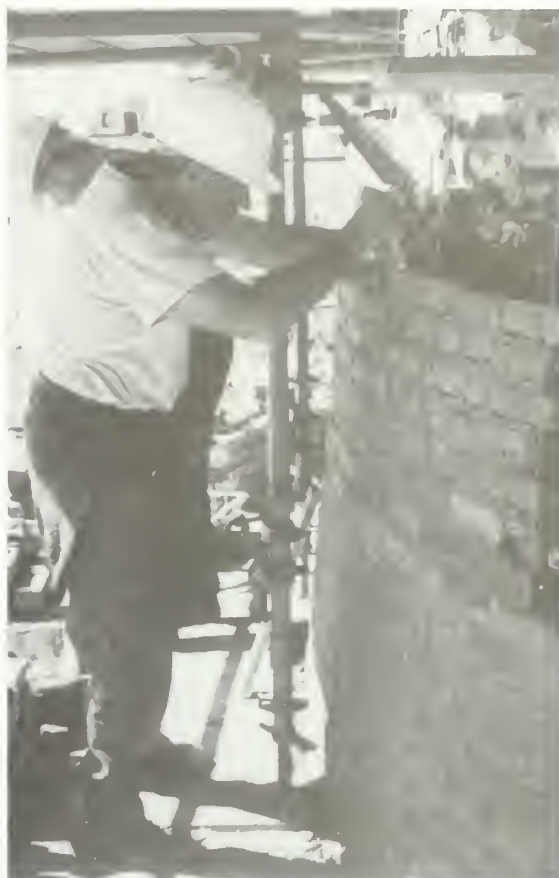
Figure 28. Here a mason is implementing repairs to the exterior wall. The missing bricks were replaced with in-kind materials: the bricks match the historic bricks in size shape and strength. The mortar joint sizes are also being made to match the historic in size, color, and texture, as demonstrated in this photo. The vertical strings over the brickwork define the wall plane, so when the mason places the bricks, they maintain the taper of the conical tower.

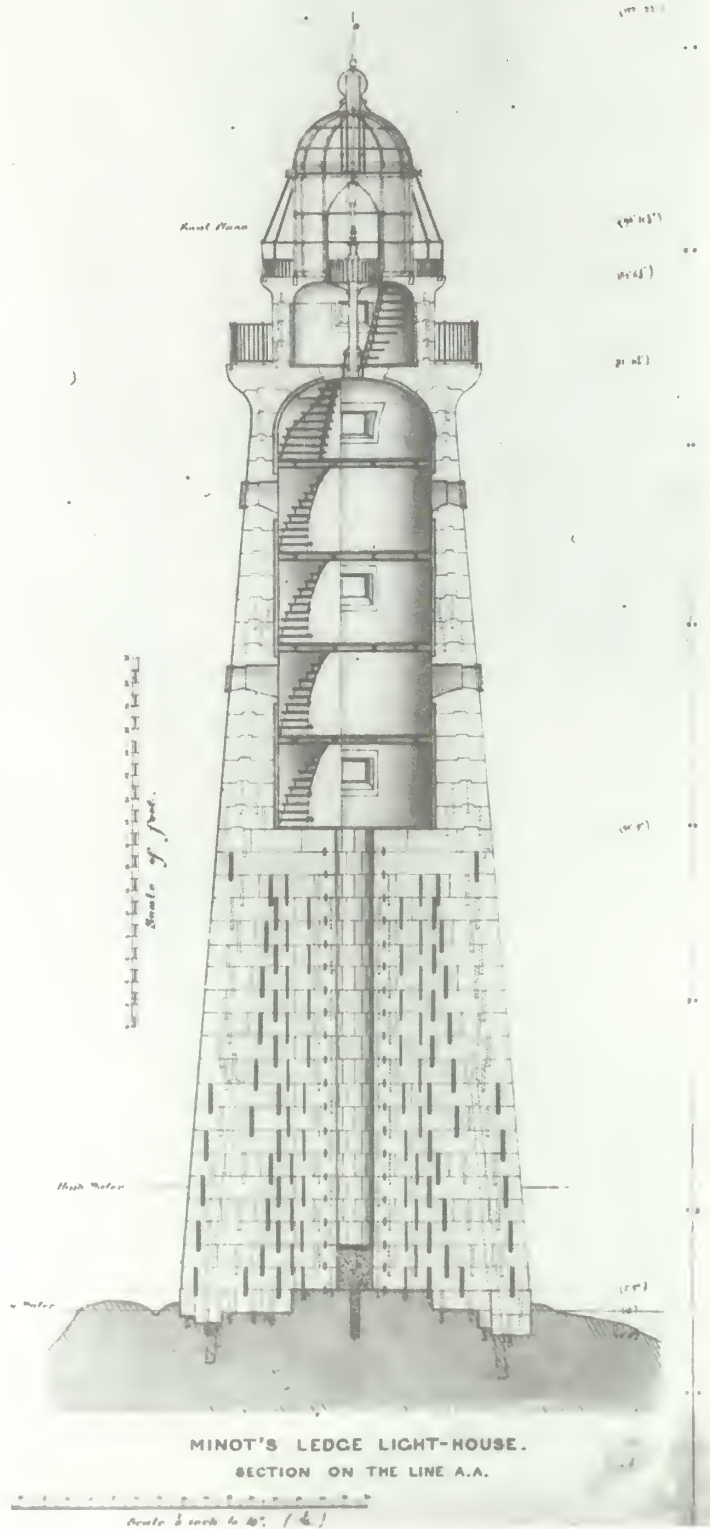
Figure 29. Cross section for 114-foot Minots Ledge Lighthouse.

On August 31, 1852, Congress approved the erection of the second and still standing lighthouse on the “Outer Minots rock.” This time the design chosen was one of interlocking granite blocks. The plans consisted of a masonry tower in the form of a frustum of a cone, solid for the lower 40 feet of its 114-foot height. Because the ledge was exposed only at low tide and on calm days, the work was very slow. Tides were found to be right only “six times during any one lunation, three at full moon and three at the change.” It took three years to prepare the ledge for the first course of granite masonry which was cut and test assembled on nearby Gulf (later called Government) Island, near Cohasset, where the government acquired 7.3 acres of farmland for a staging area for the building of the second lighthouse. Here stone-sheds were erected for the stone cutters and a perfectly flat pavement prepared so the stones once cut could be pre-assembled for correct fitness. Granite from Quincy was chosen as being “finest of grain, toughest and clearest of sap.” An iron scaffold was erected on the ledge for the safety of the

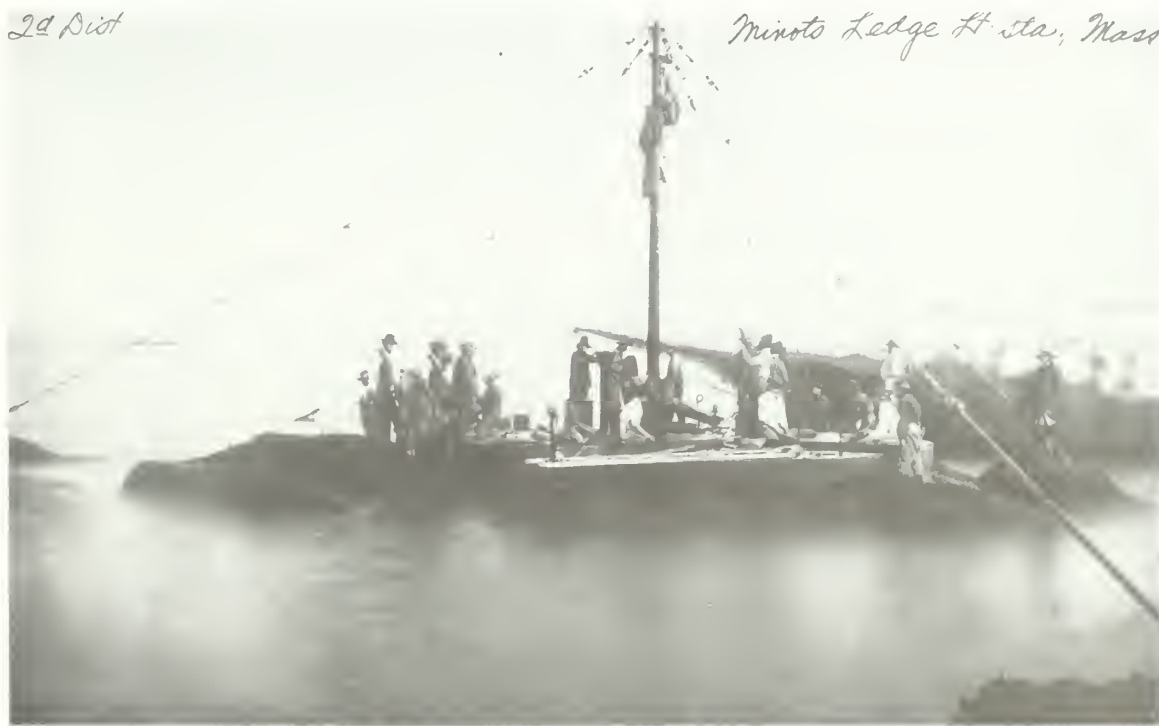
Figure 30. Workers on a calm day, completing the first course of granite block for the foundation of Minots Ledge Lighthouse, 1858

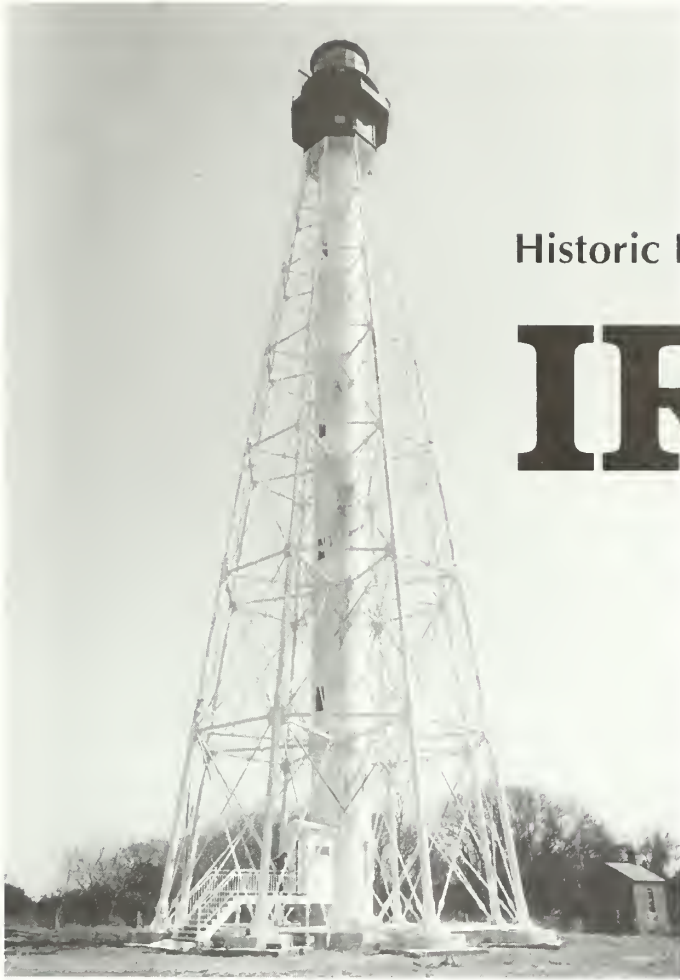
Figure 1. Cast-iron-and-steel skeletal 191-foot-tall tower at Cape Charles, Virginia

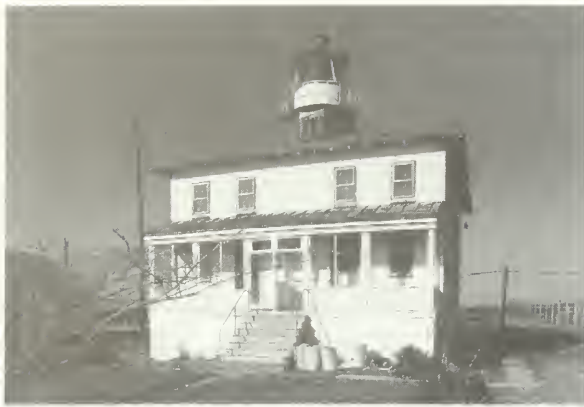
Figure 2. Example of a keeper's quarters fitted with a prefabricated cast-iron-and-steel lantern.

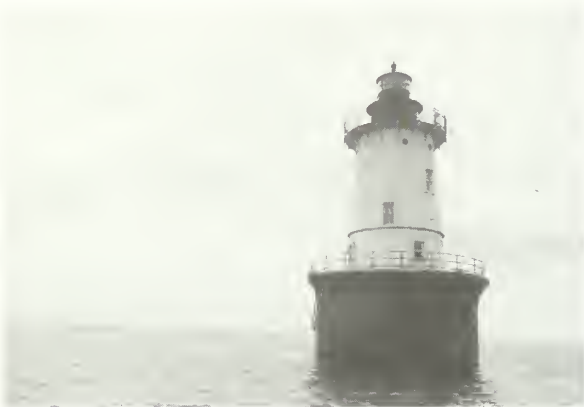
Figure 3. Example of an all-cast-iron construction "sparkplug" caisson-style lighthouse.

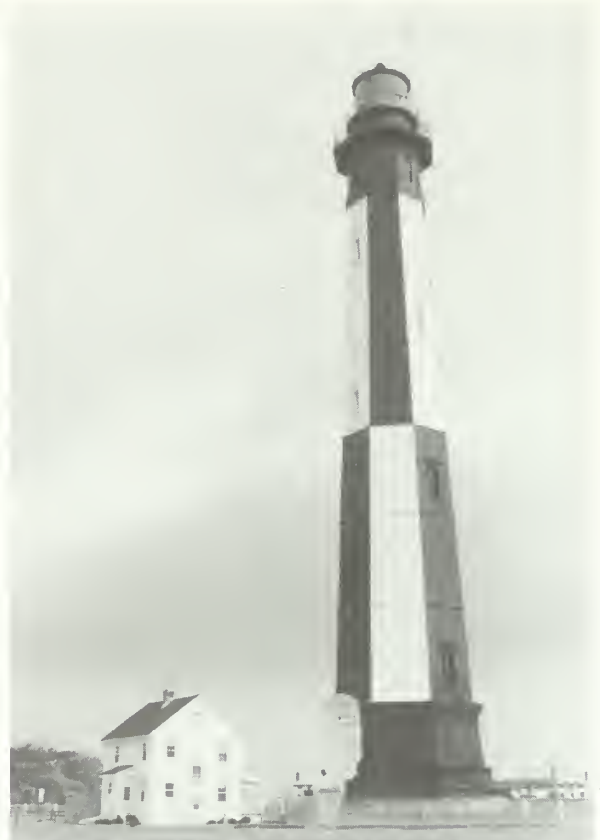
Figure 4. Double-wall, cast-iron, first-order 163-foot-tall coastal tower at Cape Henry, Virginia.

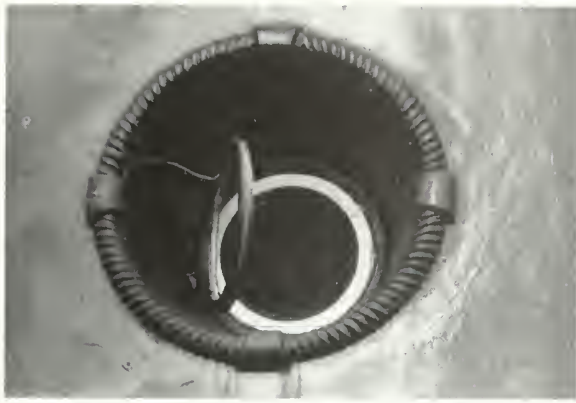
Figure 5. A view of decorative-rope nautical-style cast-iron window surrounds on Cape Canaveral Lighthouse.

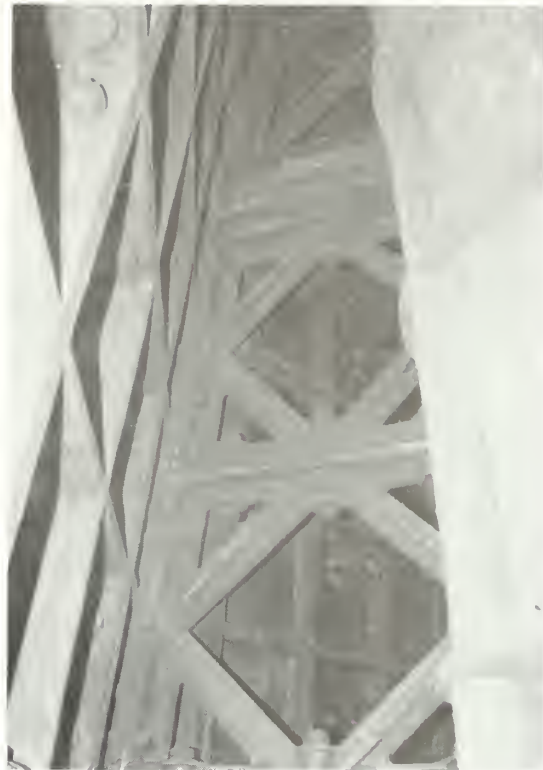
Figure 6. A view of the inner cavity and skeletal structure of the Cape Henry Lighthouse.

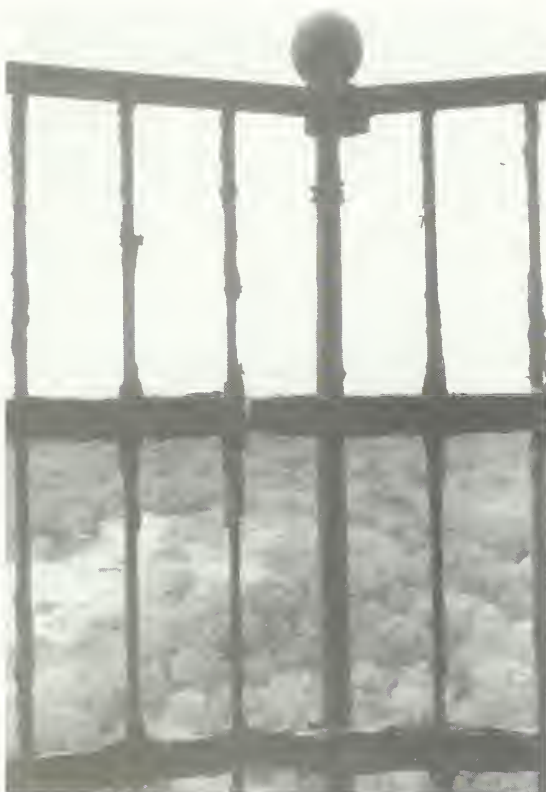
Figure 13. View of a steel railing where corrosion has occurred in distinct locations either because of variations in composition or localized failure of the coating system.

- **Uniform attack** is where the iron component corrodes evenly where exposed to corrosive agents.
- **Pitting** is the localized corrosive attack on the iron component.
- **Selective Attack** can occur where an iron component’s composition is not homogeneous and certain areas are attacked more than others.

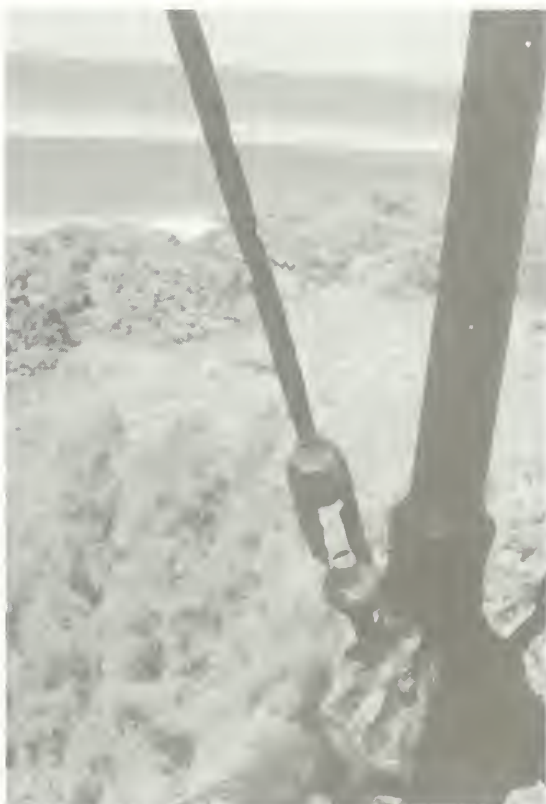
Figure 16. As corrosion attacked this steel turnbuckle, wind and airborne sand eroded away the flaking rust.

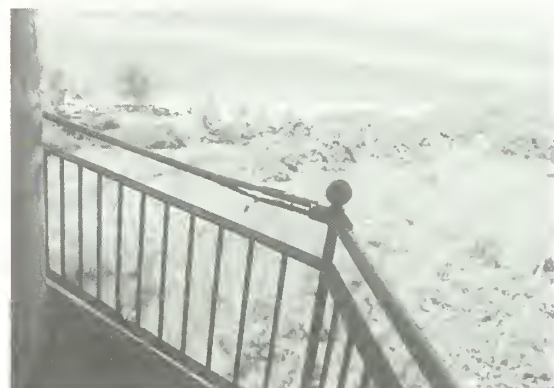
Figure 19. This handrail has been damaged by rust-jacking; rusting began between the two pieces of flat bar stock that formed the rail.

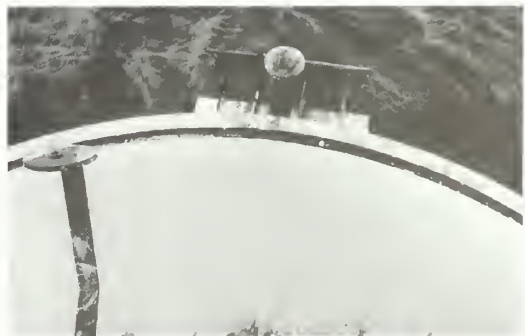
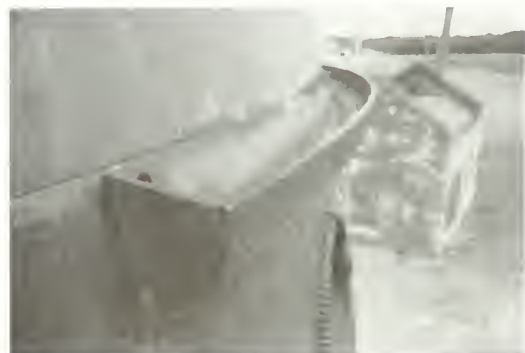
Figures 23 and 24. Two types of gutters found on iron lighthouses; the gutters must be in proper working order and checked regularly during the mothballing period.

- **Built-in guttering systems:** In order to prevent water from entering the interior cavity of double-wall iron or brick-lined iron wall systems, all rain water guttering systems (lantern roofs, or other tower roof forms) should be cleaned and checked for holes. It is imperative that all holes and non-functioning gutter system components are repaired. For more information refer to the discussion on roofing in the **Lantern** section of the handbook.

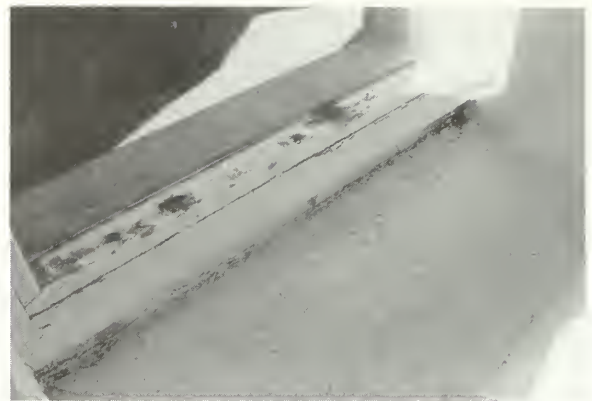
Figure 26. This steel casement window frame was not sealed properly and as a result has begun rusting from the inside out.

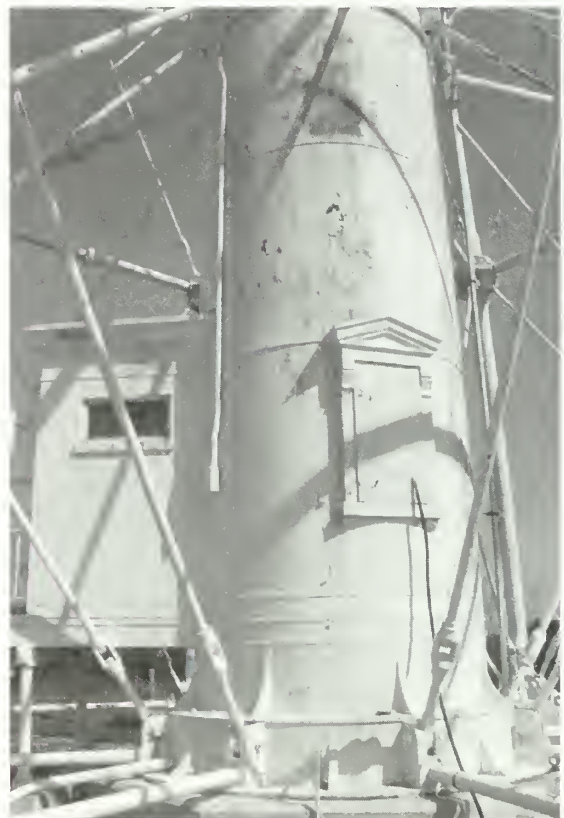
Figure 27. Blistering paint, as pictured here, should be removed and the affected areas properly primed and painted.

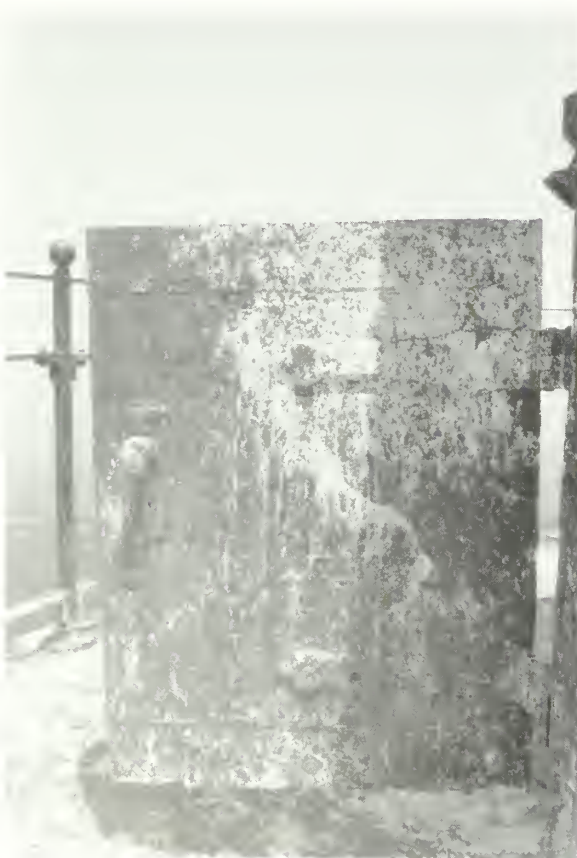
Figure 28. Surfaces such as this sheet-steel-covered parape door that are covered with seagull guano should be thoroughly cleaned before mothballing and should be checked and cleaned once a year during the mothballing period.

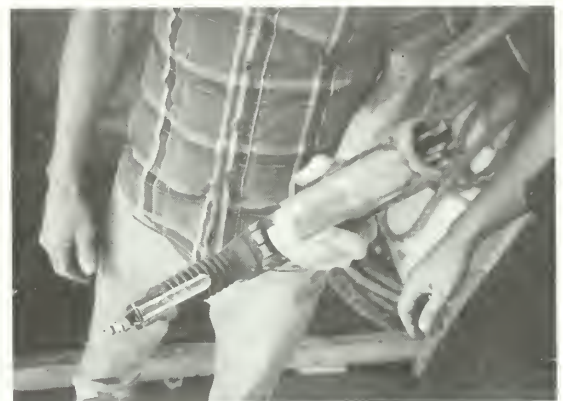
Figure 30. Close-up of a pneumatic needle gun. This tool works well for hard-to-reach and detail areas. The needle gun can be pressure-controlled to minimize impact on the iron substrate. This figure shows the vacuum-shroud connection on the right and air-hose connection on the base of the pistol-grip handle on the left.

Figures 30 through 33 are paint removal tools used during the Sand Key Lighthouse rehabilitation. Sand Key Lighthouse is located in open water off the coast of Key West. The paint being removed contained lead; therefore it was essential that all debris be contained for proper disposal.

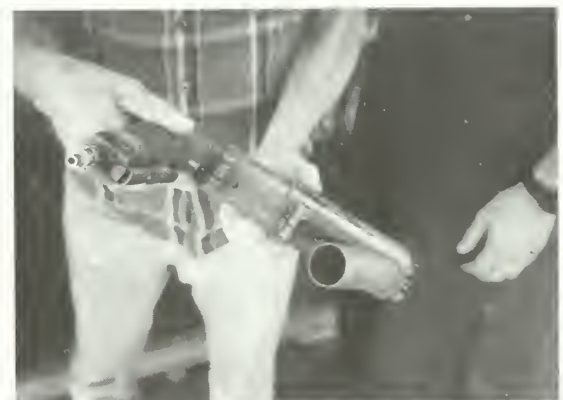
Figure 31. The gun is activated by squeezing the lever on the rubber pistol grip. The amount of air pressure controls the speed and impact of the pulsating needles against the iron substrate. The needles can be seen protruding from the vacuum shroud.

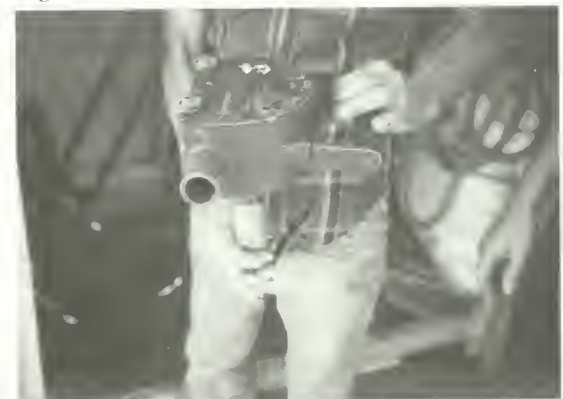
Figure 32. Close-up view of a pneumatic flush-plate tool. During the Sand Key Lighthouse rehabilitation this tool was used for all flat surfaces and for removing paint from the light-tower columns. The rollers located at the top and bottom of the shroud guide the tool over the flat and curved surfaces. The amount of air pressure controls the speed and impact of the rotating head against the iron substrate. To contain the paint dust and chips, the shroud has been outfitted with a vacuum hookup.

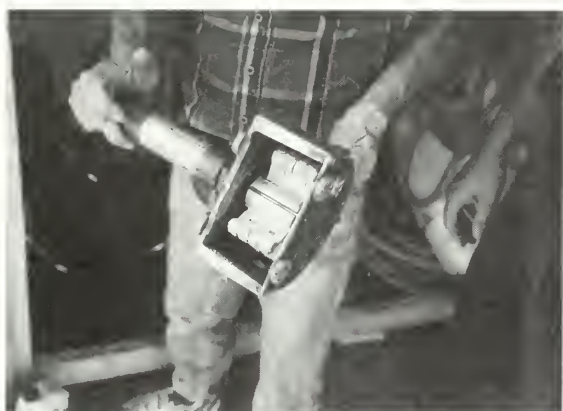
Figure 33. Close-up of the studded flaps mounted on the rotating head. To use the tool, it is held against the face of the iron member and as the studded flaps spin they “slap” the surface and “knock” the paint off the iron.

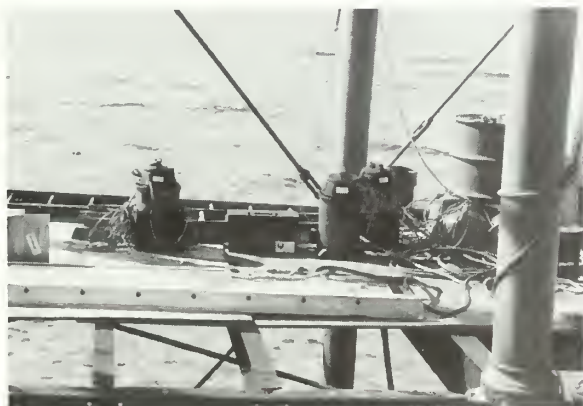
Figure 34. The small vacuums used at Sand Key Light are shown in this photo. Each vacuum has a HEPA filtration system to ensure that no lead dust escaped into the atmosphere. The conditions at Sand Key Lighthouse made the use of a large central vacuum system impractical. Using portable vacuums allowed for paint removal at numerous locations at any one time.

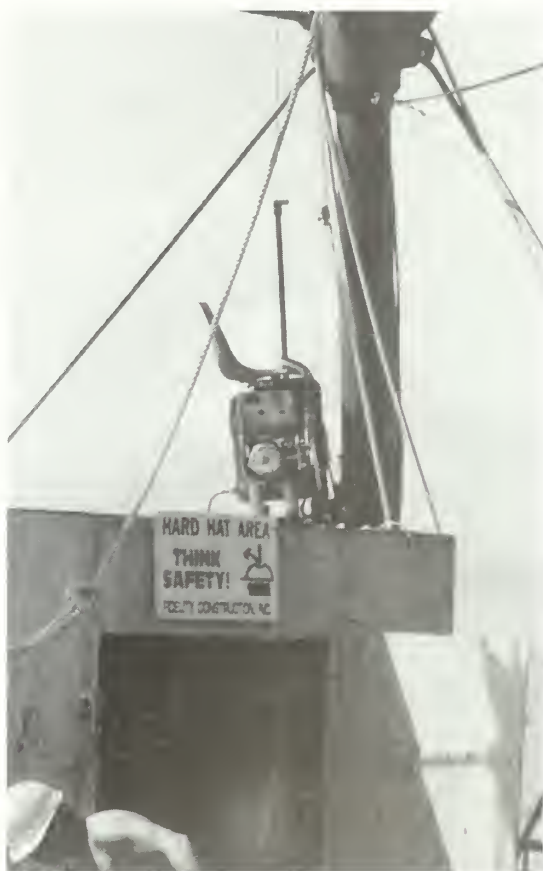
Figure 35. This motorized chair was used to hoist workers as they removed paint from the cast-iron columns at the Sand Key Lighthouse. The chair's motor is attached to a hoist, so the chair actually climbs a cable that has been strung alongside the column.

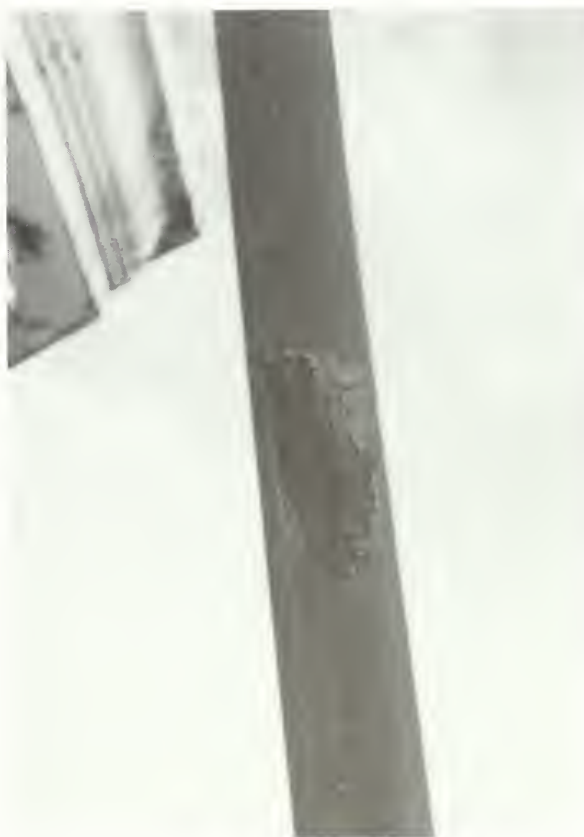
Figure 39. The finish on this tension rod failed and localized corrosion (rust) has formed. The rust is exfoliating in layers that are trapping moisture and causing corrosion to occur deeper and deeper into the tension rod. The result is pitting that will compromise the strength of the tension rod. If the area had been touched up in time, the corrosion might not have formed.

The effective protective life span of an existing paint or coating can be greatly increased by routinely touching up areas of deterioration. A small break in the protective finish can lead to accelerated corrosion of the underlying iron (see Figure 39). Areas where the paint or coating has been damaged by mechanical impact or blistering has occurred should be addressed immediately. These areas should have all loose paint and rust scale removed using one of the recommended methods

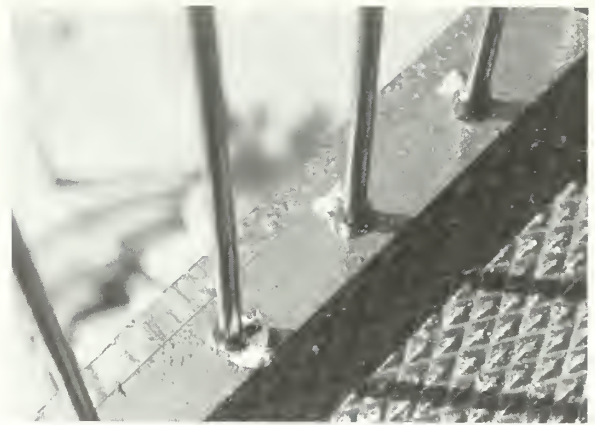
Figure 40. The paint on this stainless steel replacement gallery deck has begun to peel less than three months after it was painted. This could have been prevented if the stainless steel parts were first cleaned and then lightly glass-bead blasted.

When painting new stainless steel or other new steel or iron surfaces, special surface preparation steps must be taken. Typically these surfaces have a shop coating of light oil applied to prevent rusting. This oil must be removed with a solvent before painting. The surfaces of these materials may not have the right profile or roughness for the applied coating to adhere. To achieve the

proper profile, the surfaces should be lightly grit blasted with glass beads to achieve the profile recommended by the manufacturer.

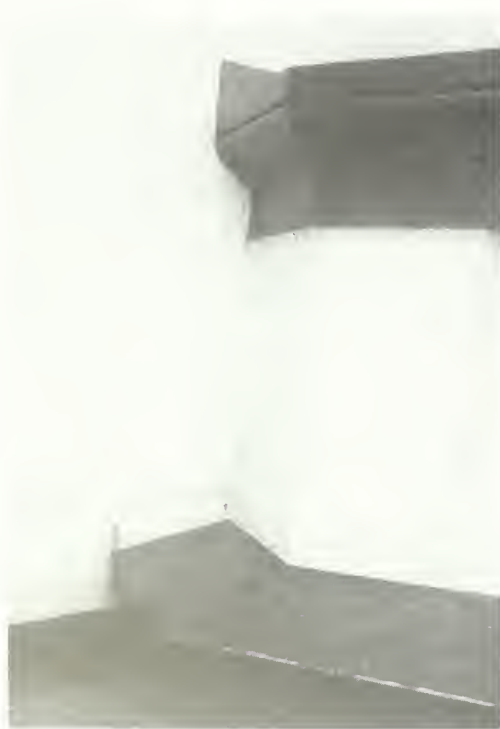
Figure 41 (left). This masonry lighthouse has been detailed with a two-tier cast-iron water table (the iron portions are painted black). Rust-bleed is occurring along lower edge of the upper tier.

A common practice in masonry lighthouse construction is to use iron door and window hoods, gallery deck brackets, belt courses, and water table caps. These details are both decorative and structural components of the lighthouse; however, they pose special preservation issues. The iron that is in contact with the masonry tends to corrode more readily than the rest of the iron component. This condition is typically evidenced by rust streaks on the masonry surface (see Figures 41 and 42). This rusting is caused by moisture either from condensation or precipitation combined with chloride or salt build-up that collects in the joint. If the joint is not sealed and the coating on the iron is failing, rust will readily form.

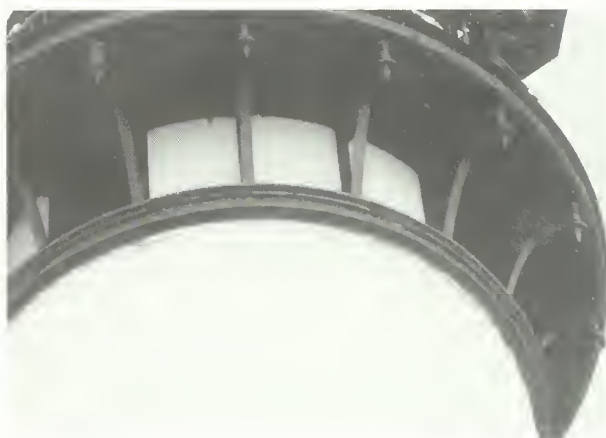
Figure 42 (above). The lower gallery deck of the same masonry lighthouse has rust-bleed occurring along the lower edge of the iron belt course that supports the gallery deck brackets.

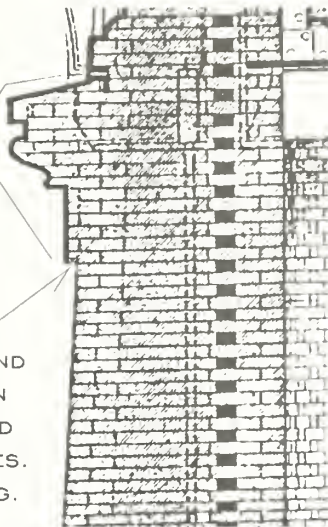
Figure 43.

CAST IRON BELT COURSE

RAKE OUT LOOSE PAINT, MORTAR, AND RUST SCALE. PRIME AND PAINT IRON AND MASONRY (IF PREVIOUSLY PAINTED OR REQUIRED BY SEALANT) SURFACES. SEAL WITH A HIGH QUALITY CAULKING.

This condition can easily be remedied if the following issues are addressed during the preservation treatment of the lighthouse. During any repairs or repainting, all masonry and iron surfaces must be cleaned of all loose paint and rust scale. All mortar that has been placed between the masonry and the iron should also be removed. The mortar helps trap moisture against the iron. Once the joint is clean, all exposed iron must be coated with a rust-inhibiting primer and top coat to provide a barrier between the iron and the mortar. The void created by the missing mortar should be filled with a new mortar mixture that matches the strength of the historic mortar (for more information on the matching of mortar strength refer to the **Masonry** section). When filling the open joint with the mortar, hold the mortar back about 1 inch. The joint should then be filled with a ½-inch-diameter polyethylene foam backer rod. To seal the joint, use a high quality silicone or urethane caulking. (Some caulks may require a painted surface to adhere to brick; therefore, the surface of the brick that will come in contact with the caulk may have to be painted before the caulk is applied). Ideally, the caulking depth should equal the joint depth up to a ½ inch. The profile on the caulking should be slightly concave to shed water. Refer to Figures 43 and 44 for more details.

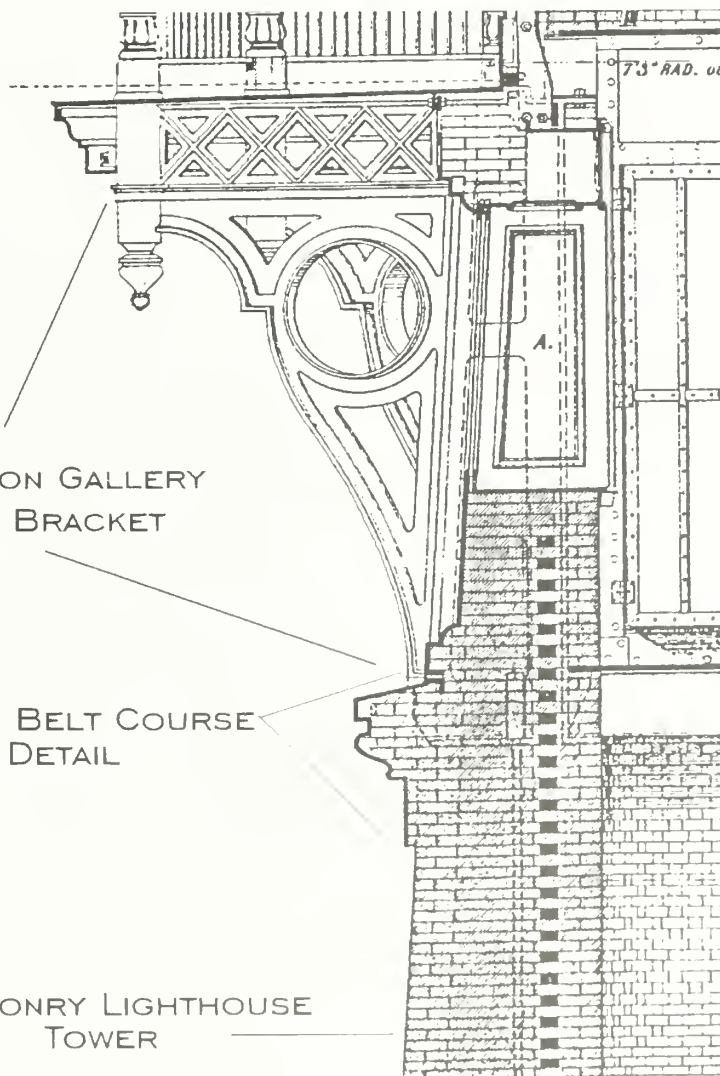
Figure 44.

CAST IRON GALLERY DECK BRACKET

CAST IRON BELT COURSE
SEE DETAIL

MASONRY LIGHTHOUSE TOWER

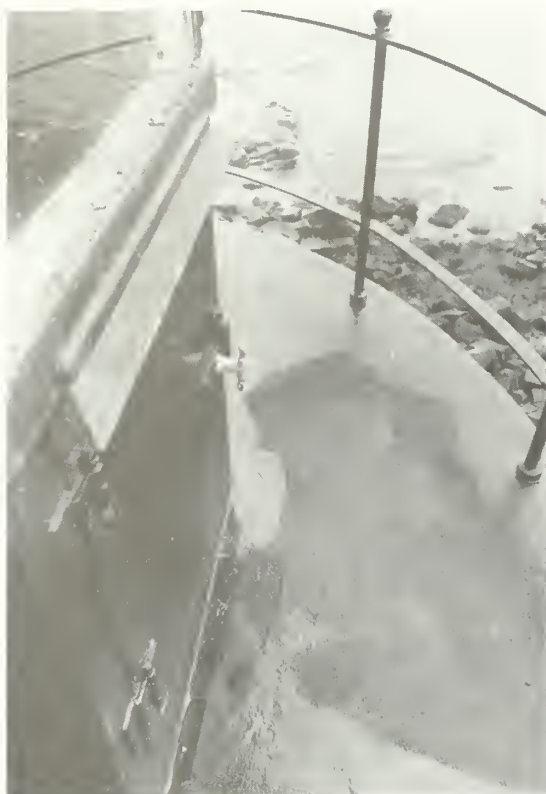
Figure 7. Ponding is occurring on this gallery deck near the base of the lantern parapet wall. This ponding has led to an active leak that occurs even during light rain conditions. A condition such as this should be remedied before the mothballing period.
